Site Inventory Form
State Historical Society of Iowa
 (November 2005)

State Inventory No. 50-00646

historic name Clarkson Building

street & number 114-118 1st Ave. E.

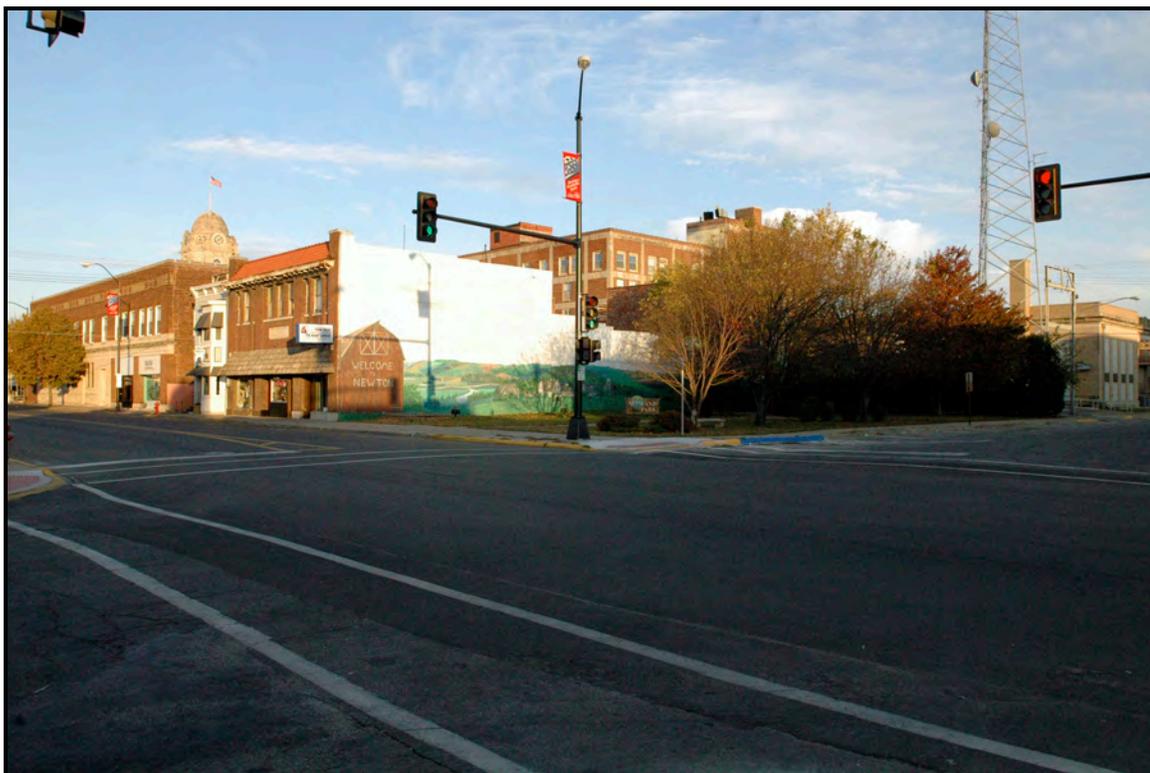
View of the north side of the 100 block of 1st Ave. E., looking northwest. The location of the Clarkson Building is indicated by an arrow.

The green space on the east is an urban park, created after a 1984 fire destroyed the adjoining building which stood on the site. The firewall on the east side of the Clarkson building was covered and painted with a mural depicting what the countryside near Newton might have looked when the area was first settled.

The east side elevation has a step-down roofline from front to the center of the building. What originally was a brick firewall has been covered in a synthetic material and painted with an artist's mural. It will be described more fully in the "property history" section.

Following a massive fire in 1984 the adjoining structure on the east was demolished, exposing the Clarkson building's brick firewall. Several years later a small park was created on the site of the vacant lot, but Clarkson's firewall remained untouched. In 2004, the brick firewall was covered in a nonhistoric material, and the "Renew Newton" organization hired artist Carl Homstad to paint this wall with a mural depicting the Newton area in its early days of settlement.

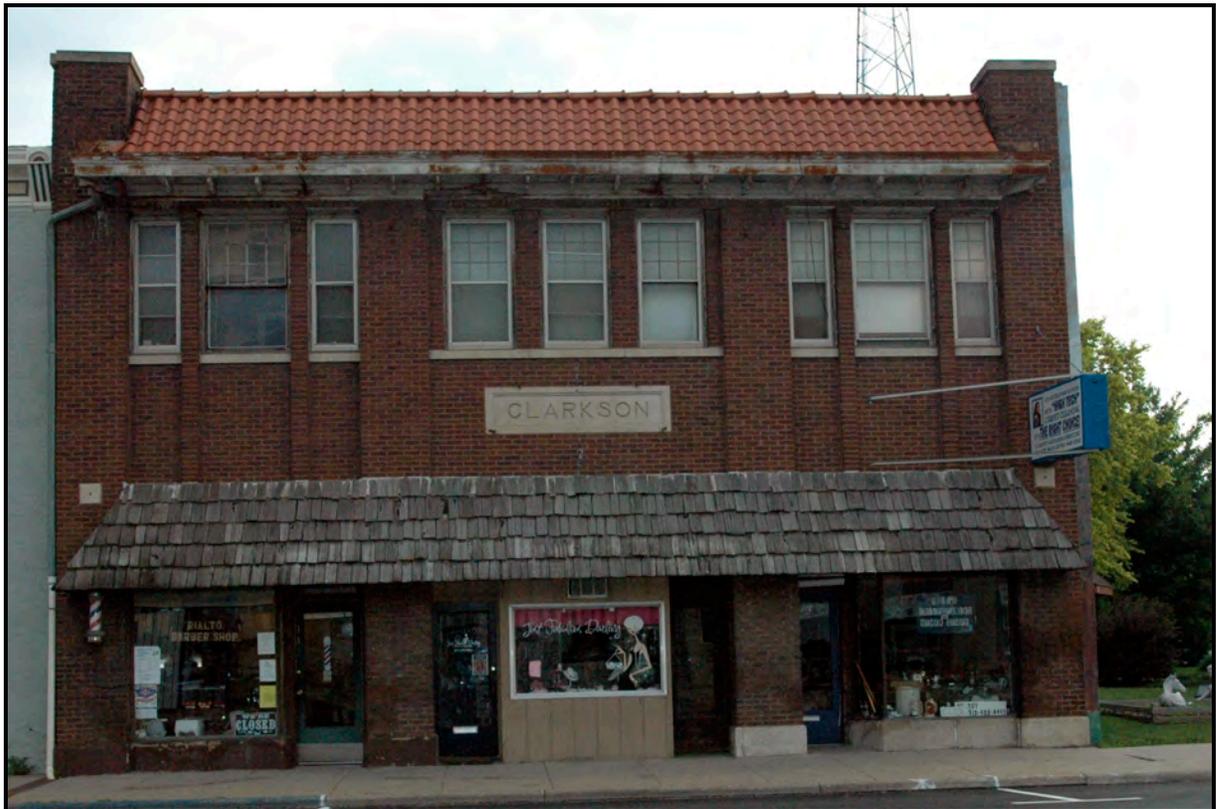
The south façade of the Clarkson Building, looking north across First Avenue East.

The façade of this 44' x 132' structure is clad in common brick and divided into three storefronts. Four large brick piers divide the façade symmetrically from bottom to top, defining the three bays. Each of the three street-level storefronts has a different bulkhead. The west bay bulkhead is painted stone block, while that on the east is unpainted stone block. The center bay, originally a movie theater with a recessed entrance, was extended flush with the rest of the building's facade in 1970. It is clad in a light-colored faux wood paneling that spans the entire first-floor storefront. A new door and display window of non-historic dimensions were also added at that time.

Each storefront in the building has one large window and its own entrance; a separate entrance marks the enclosed stairway to second floor. A non-historic cedar-shingled pent roof, added in 1970, marks the space between the first and second floors. Above this roof is a large sign, which appears to be limestone, engraved with the name "CLARKSON." A non-historic sign over the east storefront is attached to the building by metal rods.

Four small pilasters of varying sizes topped with brick corbels subdivide the second-story façade, acting as visual dividers between windows on the western and eastern bays of the building. Windows on this story appear to be the originals, with wooden muntins and metal casings; the windows are in groups of three. Each window has a single glass pane on the bottom and six, nine, or twelve panes above. Windowsills appear to be stone, and turned brick trim lies above the windows. A clay tile visor roof with wooden eaves, original to the building, overhangs the second story windows. It is partially supported by widely spaced single brackets and features terra-cotta coping. The large piers at either end of the building extend slightly above the roofline and have stone coping.

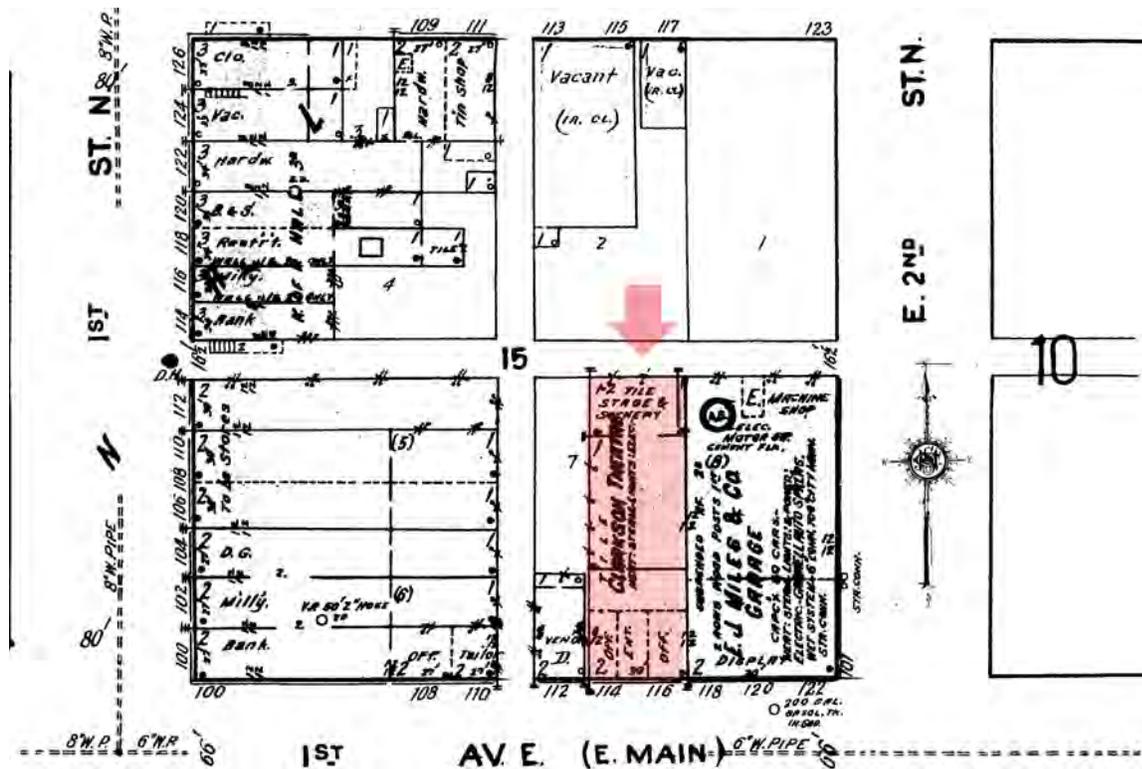
(SOURCE: Sanborn Company Fire Insurance Map, 1918)

The location of the resource is indicated. This map was drawn the year after the Clarkson Building was constructed. The address numbering system changed shortly after this map was drawn, and the 118 address became part of the Clarkson Building,

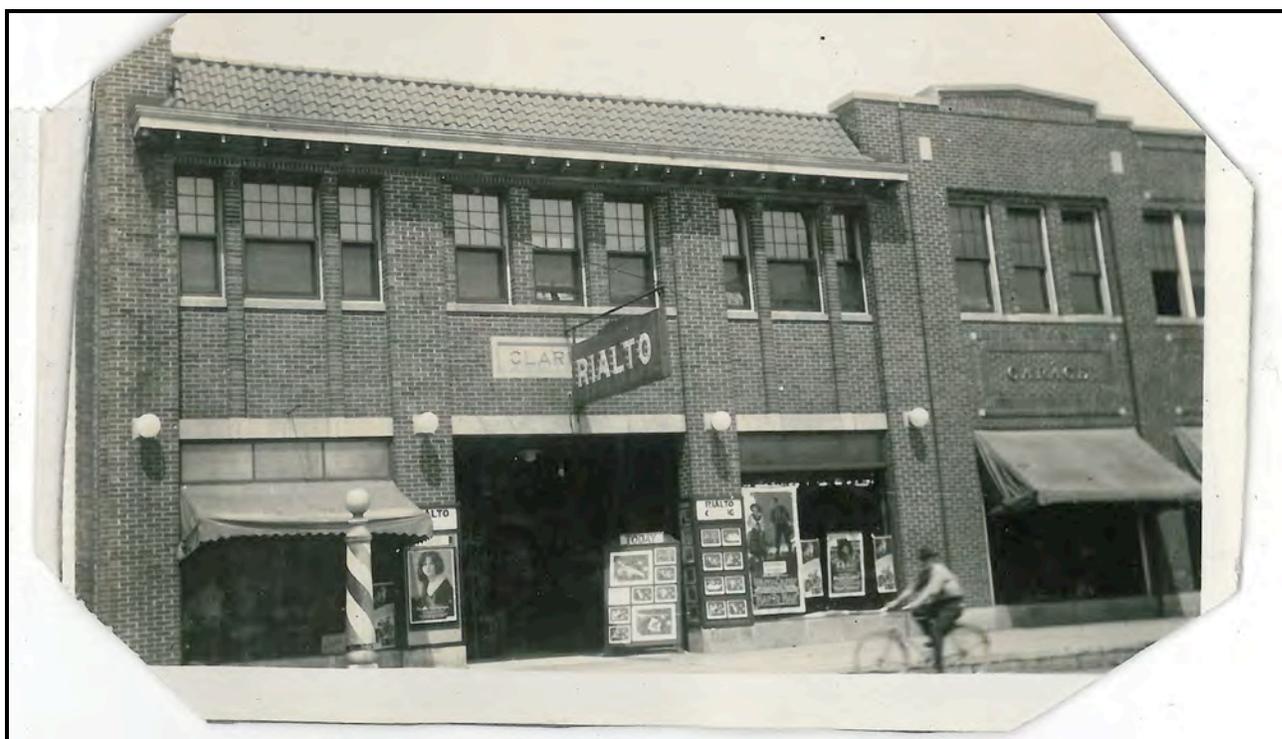
HISTORIC IMAGES – ca. 1922

This photo shows the Clarkson building and a portion of the adjoining E.J. Miles Garage building ca. 1922. In the photo the Clarkson building features globe lights on the first floor cornice, and is designated by an arrow. Although the Rialto Theater officially closed in 1954, it was not until 1970 that the recessed entry was enclosed to provide additional office space in the center section of the building. The Miles Garage building was destroyed by fire in the late 1980s, and that area is now a small city park.
